**RE: Municipal Water Licence (N7L3-0714)**

## WATER LICENCE INSPECTION FORM

<b>DATE:</b>	November 24, 2008	<b>COMPANY REP:</b>	Debbie Raddi
<b>LICENCEE:</b>	Incorporated Hamlet of Tuktoyaktuk	<b>LICENCE #:</b>	N7L3-0714

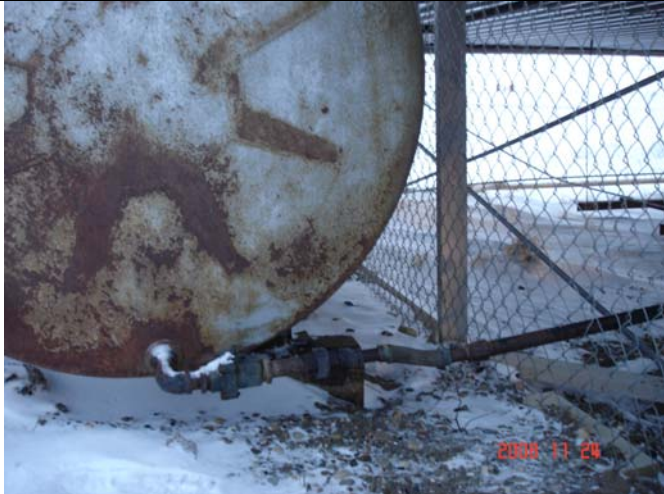
**Figure 1**

Owner:	Hamlet of Tuktoyaktuk	Operator:	Hamlet of Tuktoyaktuk	Condition of tanks:	Fair, has rusty connection points <sup>1</sup>
Berms & Liners	N/A	Water within Berm:	N/A	Evidence of Leaks:	None detected during inspection
Drainage Pipes	N/A		Pump Station and Catchment Berm		N/A
Pipeline Condition	Poor, corroded, hose flex connector mis-aligned <sup>1</sup>		Not Applicable:		N/A

Fuel Tank has rusted connection points, the flex connector is mis-aligned and piping could leak. The piping system needs to be repaired.

1. Fuel tank and hose flex connector is out of alignment. The pipeline connection to the tank needs to be repaired. Further movement of the tank and pipeline connection can cause a spill. Fuel tank has rust/corrosion at the connection points and should be replaced. Recommend moving the pipeline so it draws from the top of the tank so as to prevent future spills. (see Figure 1)

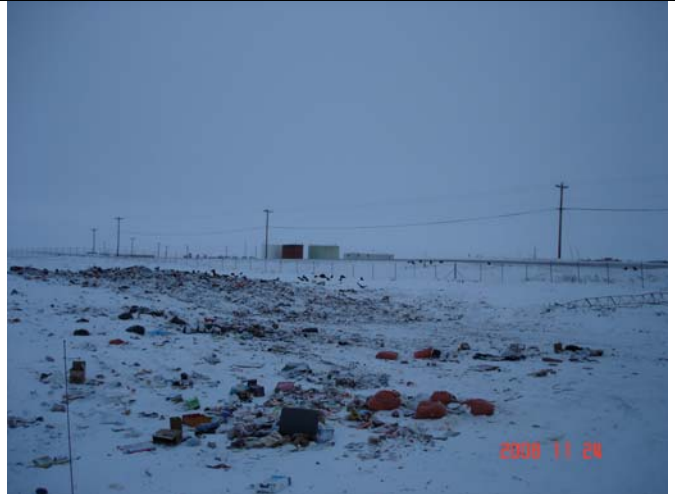
**Figure 2**

- Very little cover material to cover solid waste. This is required to ensure proper maintenance of the SWDF. This would also assist with controlling windblown debris. (see Figure 2)

Additional cover material is needed to cover solid waste and this will assist with controlling windblown debris.
