**RE: Municipal Water Licence (N7L3-1525)**

An inspection was conducted of the Municipal Water Supply and Waste Disposal Facilities on October 27, 2009. Enclosed is a copy of the Municipal Water Licence Inspection Report.

## WATER LICENCE INSPECTION FORM

<b>DATE:</b>	October 27, 2009	<b>COMPANY REP:</b>	Lena Egotak
<b>LICENCEE:</b>	Hamlet of Ulukhaktok	<b>LICENCE #:</b>	N7L3-1525

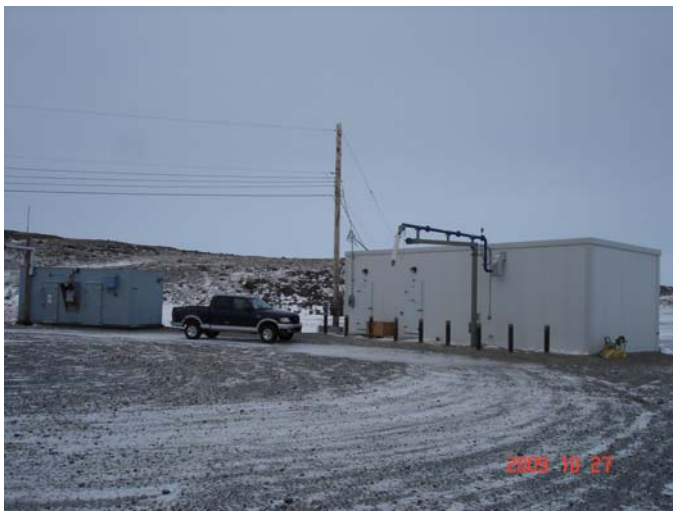
**Figure 1**

1. New Water Treatment Plant (WTP) has problems with water treatment system. Current issues are expected to be remedied shortly by supplier. In the meantime the Hamlet is batch chlorinating using the intake system of the new plant (see Figure 1).
2. Building was not secure at the time of inspection. Extra keys are being ordered and the plant is being locked at night.
3. It is evident that ATVs are in the vicinity of the WTP. Once the new WTP is fully operational and the old plant etc is taken away it is planned that boulders and/or a barricade will be installed to protect the intake line from damage. To prevent ATVs from being in the immediate area and/or on the lake it might be prudent to control access by instituting a bylaw to protect the Water Intake Facility infrastructure. This would also protect against potential spills that could damage the Hamlet's water supply.

New Water Treatment Plant at RCAF Lake. Old plant is next door to the left.

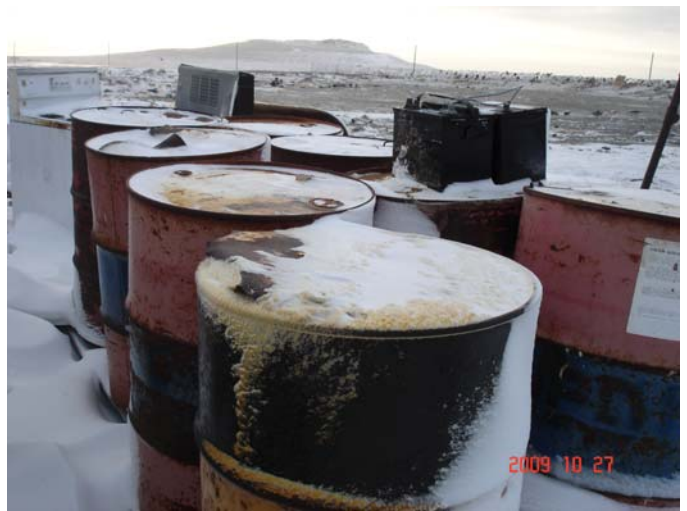
**Figure 2**

6. The batteries, waste oil and fuel at the Solid Waste Disposal Facility (SWDF) in addition to other hazardous wastes need to be properly stored in a designated bermed area to ensure proper containment. Consequently this material is located throughout the SWDF and the Hamlet. These materials need to be collected and shipped out for proper disposal at an approved facility. There is a clear indication that many containers are leaking (see Figure 2). Ensure that leaking drums and other containers are repaired and/or properly stored to prevent further leaks and spillage. Contaminated soil needs to be cleaned up and taken to a proper disposal facility.

One of many barrels at the Solid Waste Disposal Facility. There are many barrels leaking and needing proper disposal.

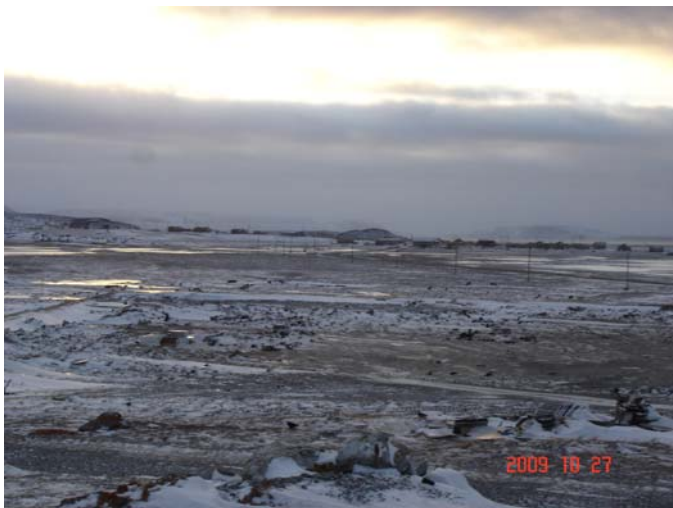
**Figure 3**

8. There is visibly more material covering the waste at the SWDF but windblown debris is still present. Higher berms on all sides with fencing and continued regular cover material will prevent exposure to the wind and control windblown debris (see Figure 3).

The added cover material on the Solid Waste Disposal Facility. Higher berms and fencing is needed all around to control windblown debris.

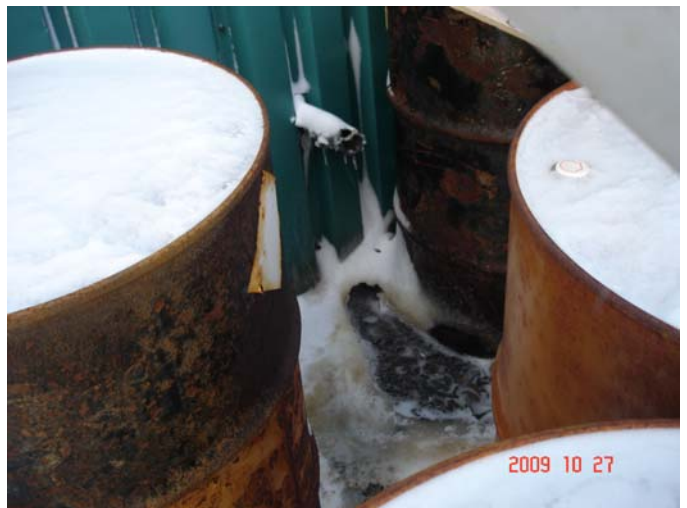
**Figure 4**

10. Hamlet's Mechanic Shop wash water from the sink going through a pipe outside and no waste water containment is present (see Figure 4). It is unacceptable for wash water from the shop to be disposed of on the ground. Proper waste containment needs to be installed as soon as possible. This has been occurring for a number of years.

The Hamlet's Mechanics Shop with no waste water containment present. Proper waste containment is needed.
