RE: Municipal Water Licence (N7L3-1619)

WATER LICENCE INSPECTION REPORT

DATE:	October 15, 2008	COMPANY REP:	Debbie Gordon-Ruben
LICENCEE:	Hamlet of Paulatuk	LICENCE #:	N7L3-1619

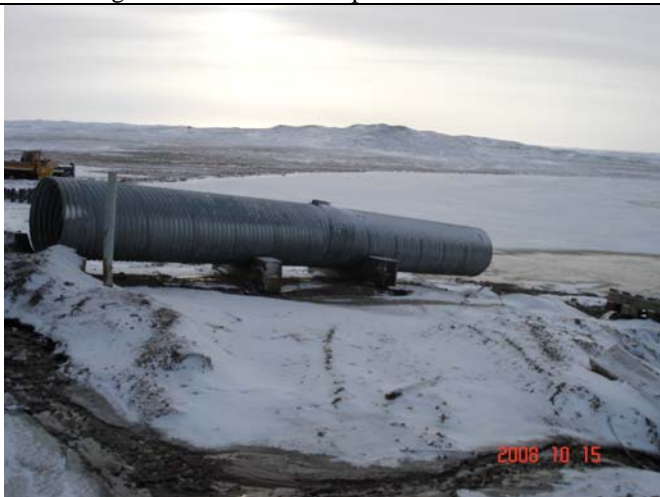
Figure 1

4. Sewage is bypassing the front of the sewage discharge chute and causing erosion all around the chute. The chute needs to: have a funnel at the front to prevent bypassing, a longer chute or move closer to the lagoon, have a turn around pad extended with truck tire stops(blocks or curb). (see Figure 1)

Sewage chute needs: a funnel for the front, to empty directly into the lagoon and truck tire stops.

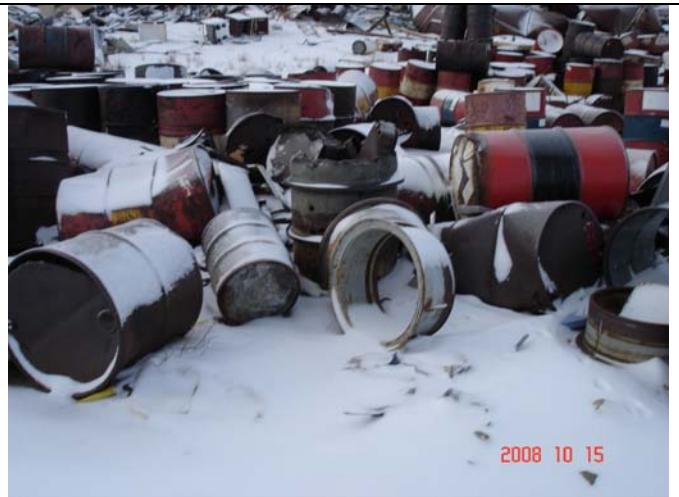
Figure 2

6. Barrels and contained materials need proper disposal. (see Figure 2)

Barrels and contained material need proper disposal.

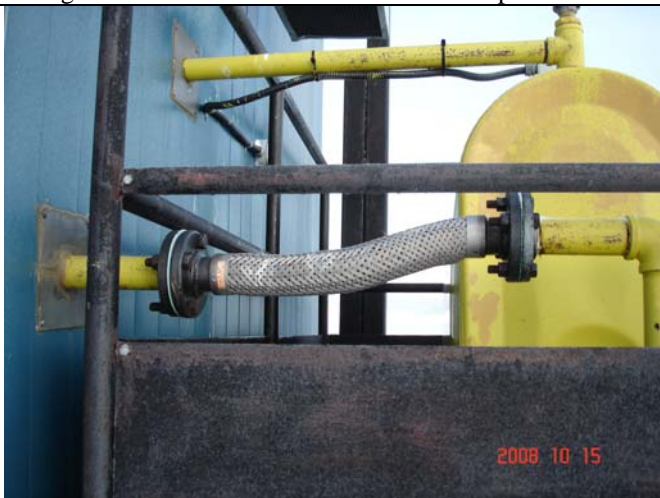
Figure 3

1. Flex connector is showing signs of being out of alignment. It is time to re-align the tank and fuel line fittings. If there is more movement of the pipe and connection there could be a spill into the Hamlet’s water supply. (see Figure 3)
2. Frozen water was present inside the berm for the fuel storage tank. The ice could rupture a bottom fitting for the fuel tank and cause a spill. The ice already decreases the containment capacity of the berm. (see Figure 4)

Flex connector is out of alignment. Tank and pipe need to be re-aligned. Further movement could cause a spill.

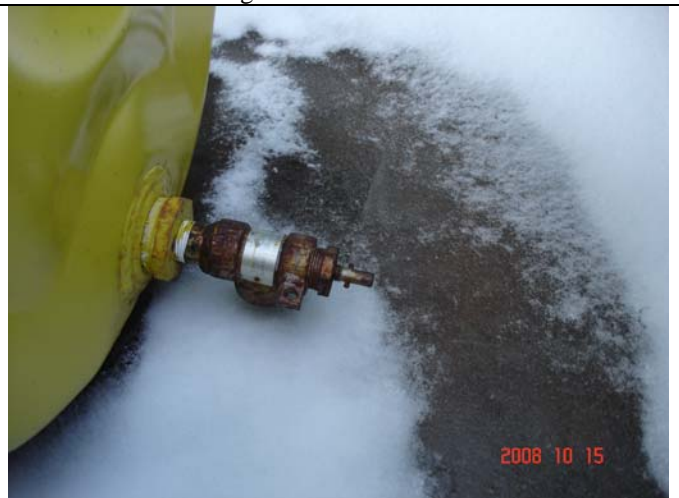
Figure 4

Frozen ice in bottom of berm threatens to break fitting on the base of the Fuel Storage Tank at Water Treatment Plant.

- Recommend regular snow removal or a roof/enclosure constructed over fuel storage tank to prevent further water inside bermed area.
