RE: Municipal Water Licence (N7L3-1619)

WATER LICENCE INSPECTION REPORT

DATE:	September 25-26, 2007	COMPANY REP:	Gilbert Ruben – Truckfill Operator Aaron Ruben – Water Treatment Plant Operator
LICENCEE:	Hamlet of Paulatuk	LICENCE #:	N7L3-1619

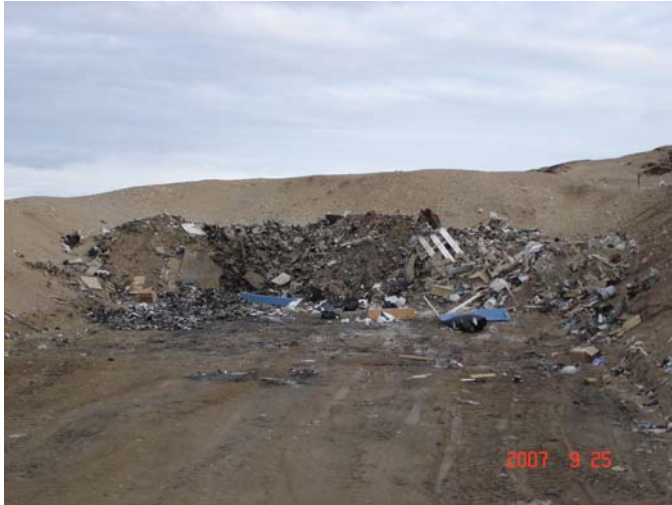
Figure 1

1. Burning of non-segregated Municipal Solid Waste (MSW) is occurring. Burning of non-segregated MSW remains an unacceptable option for the management of MSW. Wastes that are conditionally suitable for open burning are paper products, paperboard packaging and untreated wood wastes according to the document from the GNWT Department of Environment and Natural Resources titled 'Municipal Solid Wastes Suitable for Open Burning' (Please see enclosed document and Figure 1).

Burning of un-segregated domestic solid waste.

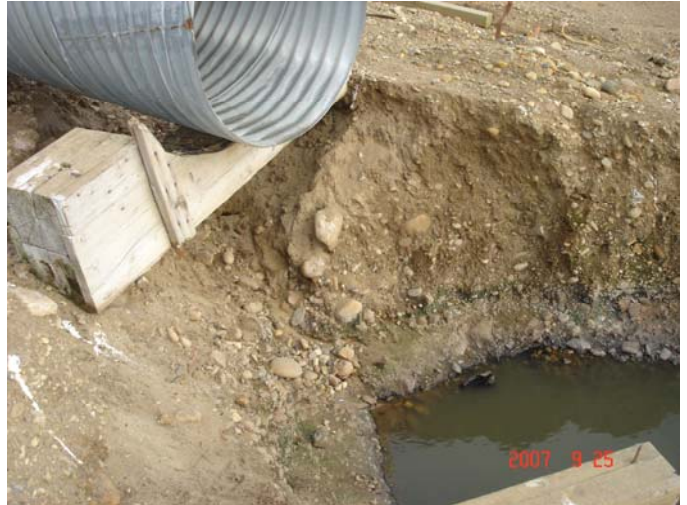
Figure 2

2. Sewage is bypassing the front of the sewage discharge chute and causing erosion all around the chute. The chute needs to be upgraded to prevent sewage from bypassing the front of the chute and to withstand erosion (Figure 2).

Erosion present at the end of the sewage unloading chute.

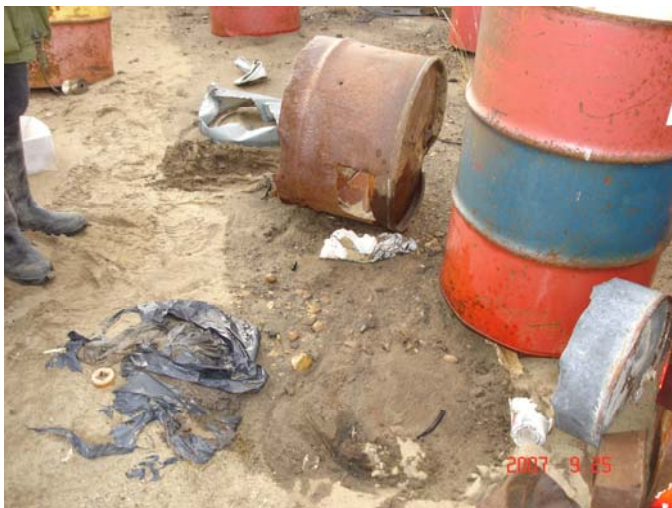
Figure 3

3. At the time of inspection someone had recently overturned a drum and dumped the contents at the Solid Waste Disposal Facility(SWDF) in amongst the drum storage area. There was a presence of hydrocarbon odour and it was clear the liquid had run down along the sandy soil area. This kind of situation should be reported to the Spill Line and the spill area should be cleaned up and properly disposed of. Spills of oil and other materials were evident among the drum storage area (Figure 3).

Evidence of drum's contents spilled at drum storage area.

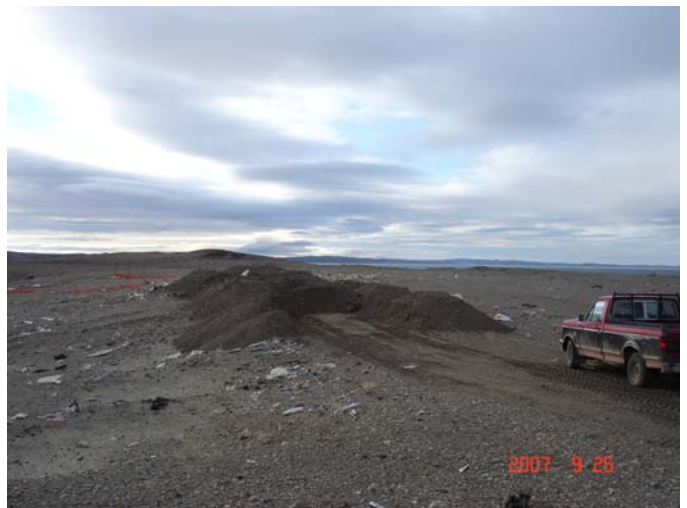
Figure 4

5. Discharge quality is unknown. Hamlet has not been sampling on a regular basis as per Surveillance Network Program requirements.
6. At the time of inspection contaminated soil was at the SWDF. The presence of contaminated soil occurred as a modification to the SWDF and the Operation and Maintenance Plan without notification of the Northwest Territories Water Board. The presence of contaminated soil at the SWDF without proper containment is unacceptable and could lead to further contamination. The Hamlet needs to comply with the Water Licence Part E: Conditions Applying to Modifications. Contaminated soil needs proper containment as per Water Licence Part G: Conditions Applying to Construction (Figure 4).

Contaminated soil pile area at Solid Waste Disposal Facility.
